Solving Common Coating Problems

Using this chart

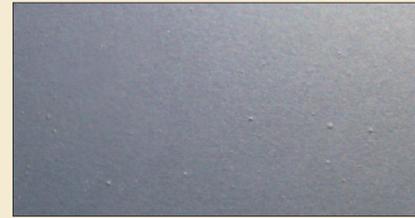
Bubbles, pinholes

Many small pock marks or tiny holes in the coating.

1. Excessive agitation, causing coating to foam, trapping gas or air in bubbles.
2. Excessive pumping or a leaking pump.
3. Rapid evaporation of solvent.

1. Reduce agitation in tank and check pumping process.
2. Add slow-evaporating solvent.
3. Warm parts more gradually, flash briefly before curing.

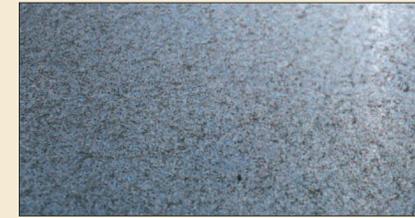
Cobwebbing

Small strands of coating resin on the surface.

Fluid coating is drying as it is sprayed before it reaches the surface to be coated.

1. Reduce the air pressure in the delivery system to prevent premature drying.
2. Change to a solvent that dries more slowly.
3. Reduce viscosity.

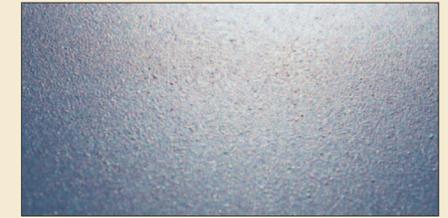
Dry spray

A rough, mottled surface, similar to orange peel.

The coating is losing too much solvent as it is propelled toward the surface by the spray gun.

1. Move the spray gun closer to the surface; reduce the velocity of the spray; or increase the ratio of coating to air in the spray.
2. Change to a solvent that dries more slowly.

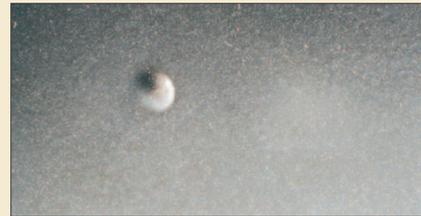
Eruptions in die-cast parts

Occasional, random eruptions and/or small pock marks.

Microcavities containing air in the metal. The air expands during curing, erupting (outgassing) and leaving either a small eruption or a crater.

1. Force eruptions prior to coating by preheating the parts to a temperature above the cure temperature. If no blisters appear, let parts cool, then coat and cure. If blisters still appear, advise your customer.
2. Select coating with lower cure temperature.

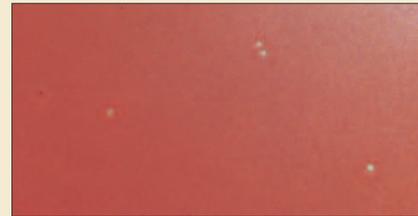
Fish eyes

Round, crater-like holes that penetrate to the substrate.

Contaminants that prevent coating from wetting out the surface (such as grease from fingerprints or oil in the compressed air).

1. Review the handling, cleaning and surface preparation procedures to assure surface is free from contamination prior to coating.
2. Check for possibility of silicone contamination.
3. Install/check efficiency of oil/water trap

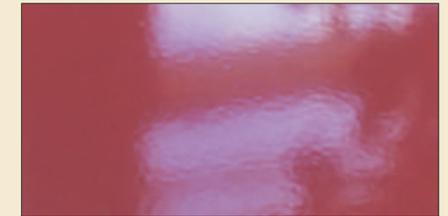
Orange peel

Textured coating surface resembling skin of an orange.

1. High viscosity of the coating material.
2. High temperatures causing rapid solvent loss.

1. Decrease the viscosity and lower air pressure.
2. Reduce the temperature of the part.

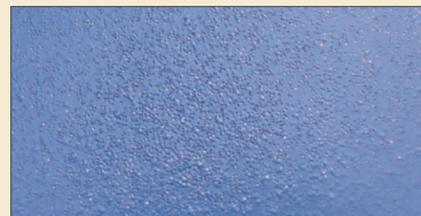
Overspray cratering

Small particles of coating that reach a surface not intentionally sprayed (such as overspray from an interior non-stick reaching the exterior of a pan).

Too much overspray in application process.

1. Move the spray gun closer to the surface; reduce the velocity of the spray; or increase the ratio of coating to air in the spray.
2. Mask part to avoid overspray reaching other surfaces.
3. Increase air exhaust around parts to remove spray.

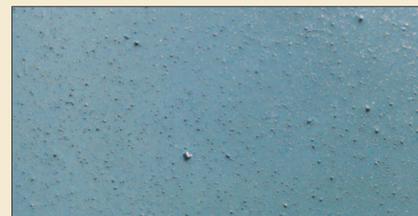
Particulate contamination

Hard bits (particles) on surface of coated parts.

1. Dried coating inside container falling back into coating.
2. Airborne particles either in spray area or oven.

1. Filter coating before using.
2. Keep spray area clean and free of dust.
3. Vacuum particulate matter from oven.
