# COATING WORLD<sup>®</sup>

SPECIAL REPORT ON NONSTICK COATINGS AND HOUSEWARES FOR RETAILERS

## Keeping Nonstick Coatings Honest: Whitford's Testing Equipment And Methodology

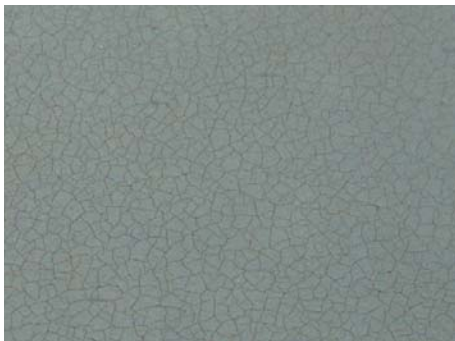
*"Mud-cracking" caused by the application of too much coating.*

Too little coating leads to rapid wear of the nonstick. Too much coating can cause "mud-cracking" (much the same effect that occurs when a lake bed dries out and the mud separates, showing deep cracks). This leads to wear and occasional failure of the nonstick, since the cracks are easily penetrated by foodstuffs.

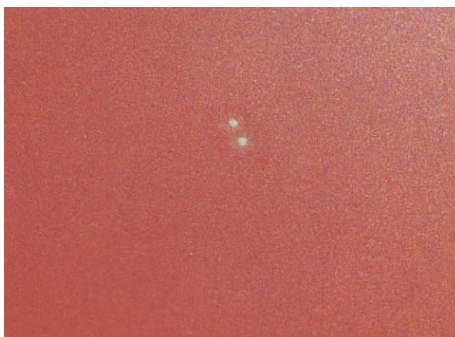
*"Fish eyes", small holes caused by contaminants (such as fingerprints) on the surface.*

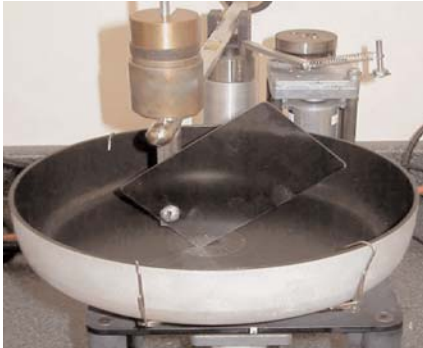
*Whitford's Knife Cut and Scrape Test: a fast, reliable way to measure the wear resistance of a coating.*

**5. The Knife Cut and Scrape Test (Whitford Test Method 137E):** This simulates the cutting and scraping action of metal utensils, particularly spatulas, on a nonstick surface. It measures the resistance to slicing through the coatings as well as resistance to sideways scraping of a blade.

The pan is positioned onto the center of a turntable that rotates. An industry-standard Q-Panel is locked into place under an arm weighted with

900 grams to simulate a knife. The turntable revolves at a speed of 15 rpm and the fixture arm oscillates at 21 rpm.

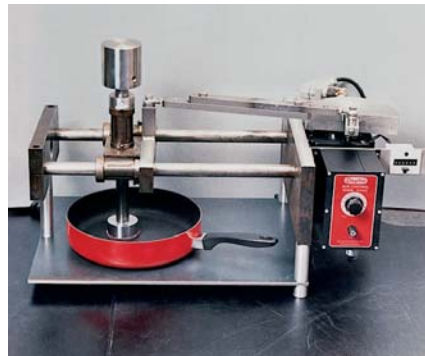
*The Reciprocating Abrasion Test replicates marring from scouring, stirring spoons, etc.*

This test is designed to measure the ability of a nonstick coating to withstand the abrasion created by scouring and similar forms of damage associated with cleaning pots and pans. The test apparatus was designed by Whitford technicians, but is applicable

The test machine moves a weighted stylus in a straight line forward and backward over the coated surface. Fixed to the bottom of the stylus is a standard Scotch-Brite® abrasive pad, the exact size of the bottom of the stylus. Pads are changed every 1,000 cycles. The test apparatus has a counter to measure the number of cycles.

Whitford ends the test once 10 percent of the substrate is abraded by the pad, at which point the number of cycles is recorded for comparison.
